**AFTER-ACTION LETTER REPORT
THE FORMER STATLER HILTON HOTEL SITE
1539 WASHINGTON BLVD.
DETROIT, WAYNE COUNTY, MICHIGAN
TDD#: 0308-003**

July 2004

Re: After-Action Letter Report
Former Statler Hilton Hotel Site
1539 Washington Blvd.
Detroit, Wayne County, Michigan
TDD: 0308-003

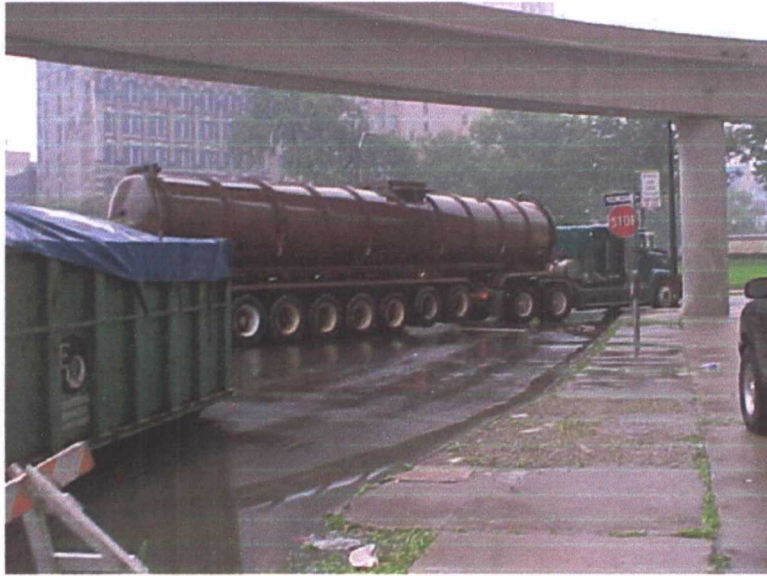
SUBJECT: 10,000 gallon tanker truck leaving site to
US Liquids for disposal

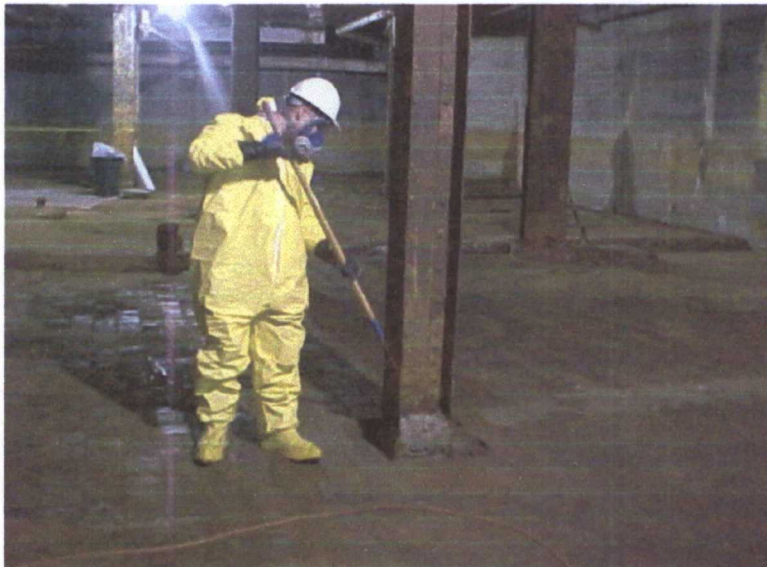
SUBJECT: ERRS personnel scraping beams in
basement area

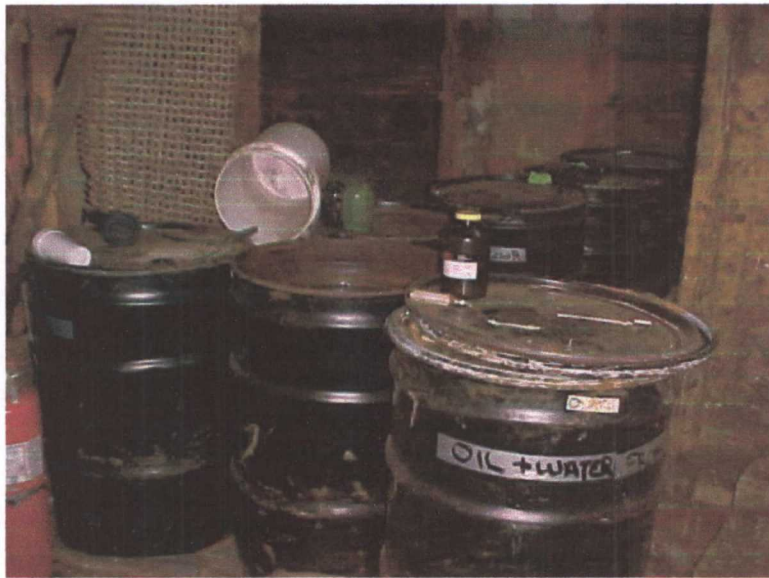
SUBJECT: Drums of oil and water from transformer area ready for disposal

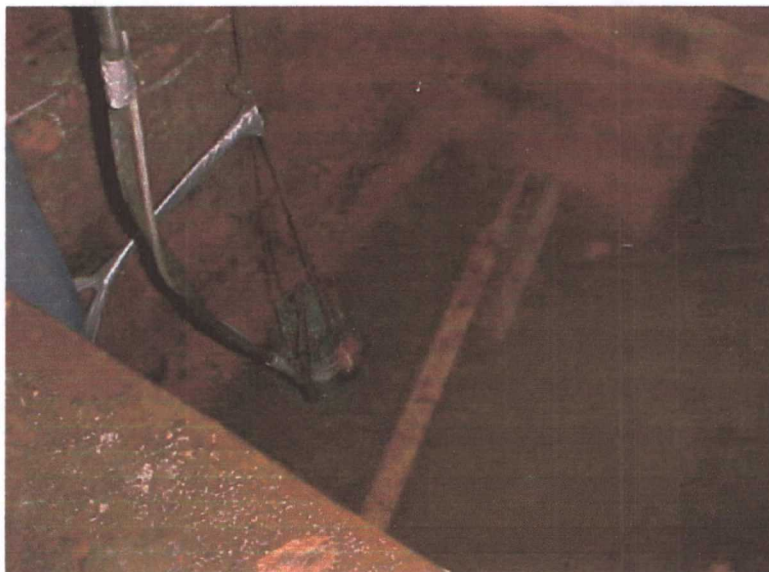
SUBJECT: Pump removing water from sub-basement

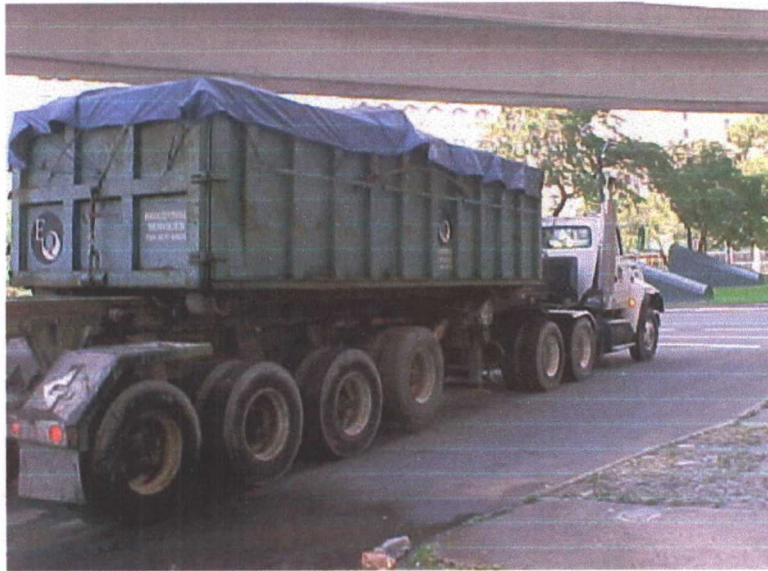
SUBJECT: Truck leaving site with full roll-off

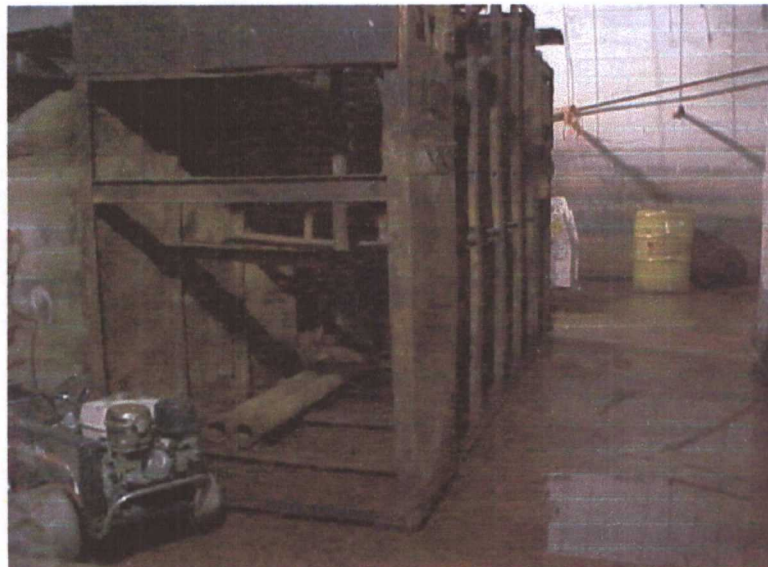
SUBJECT: Capacitor closet where capacitors once were located.

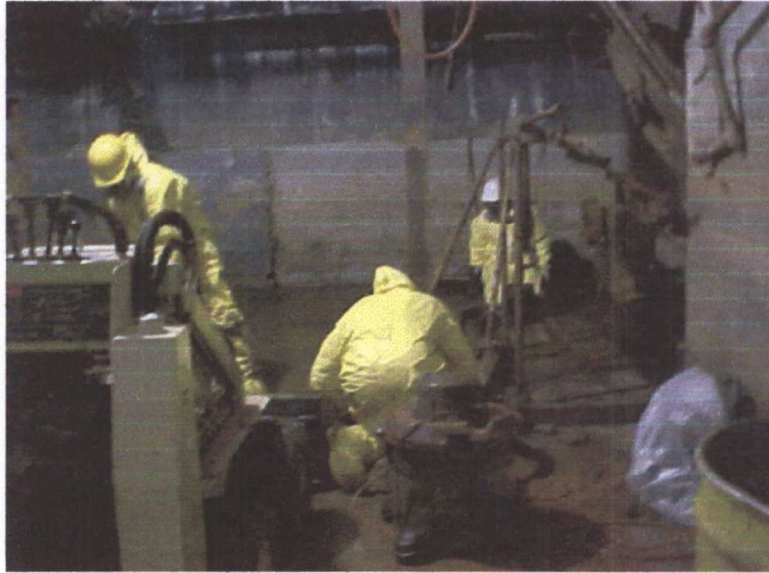
SUBJECT: ERRS personnel scraping and removing loose debris

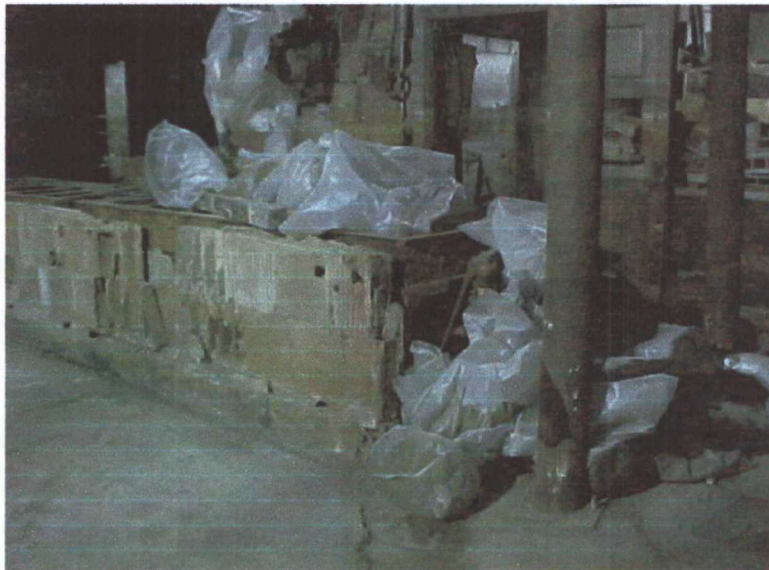
SUBJECT: Suspect PCB-contaminated ACM found on the floor in the basement area

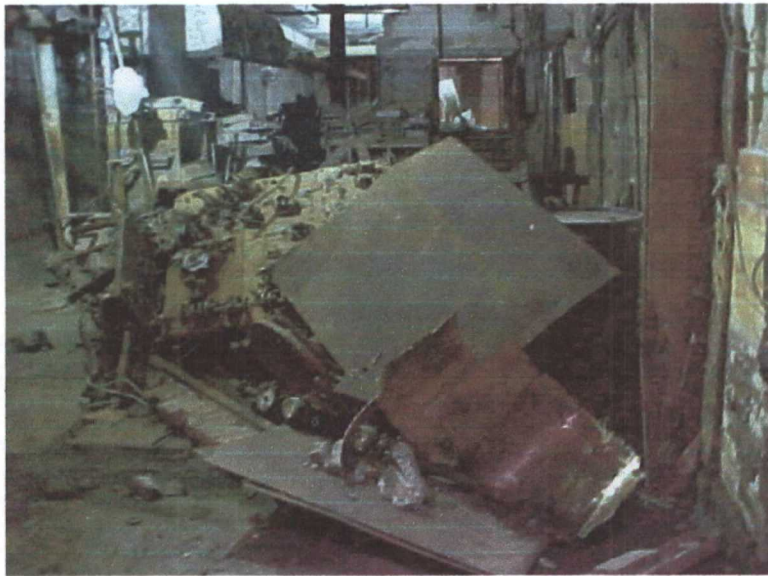
SUBJECT: Debris pile ready for removal into roll-off

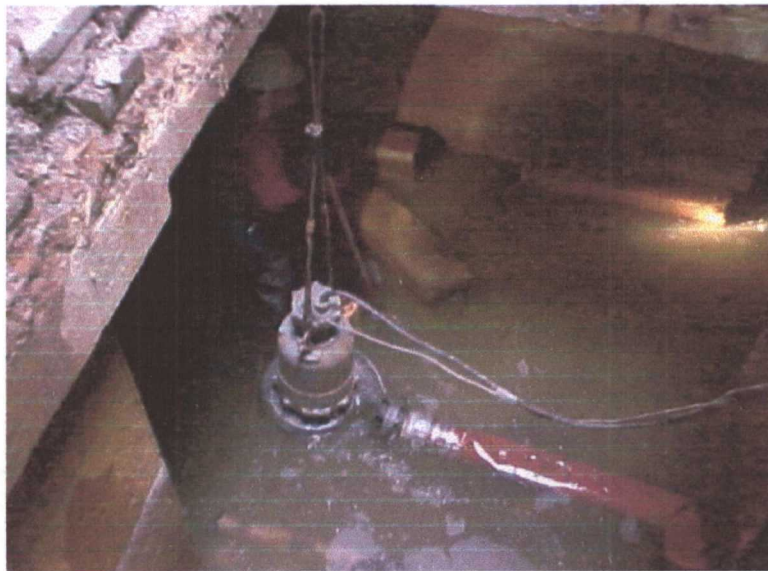
SUBJECT: Pump after removing estimated 250,000 gallons from sub-basement

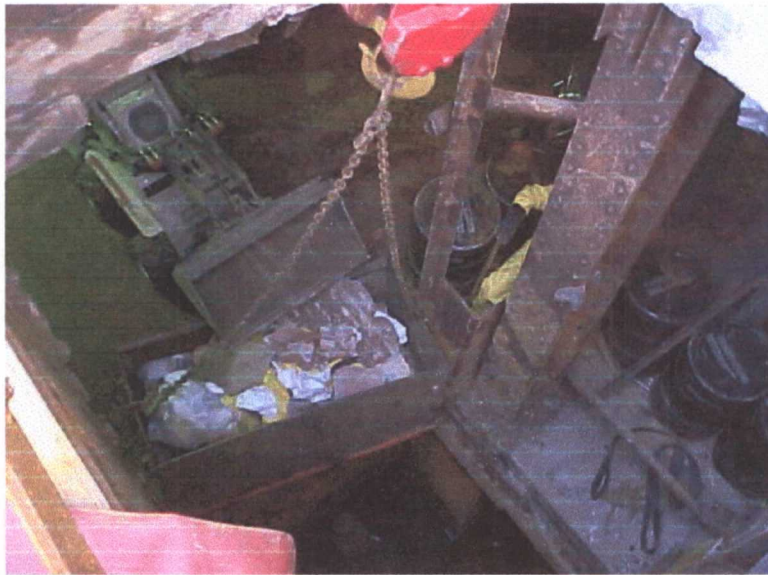
SUBJECT: Crew removing debris from basement

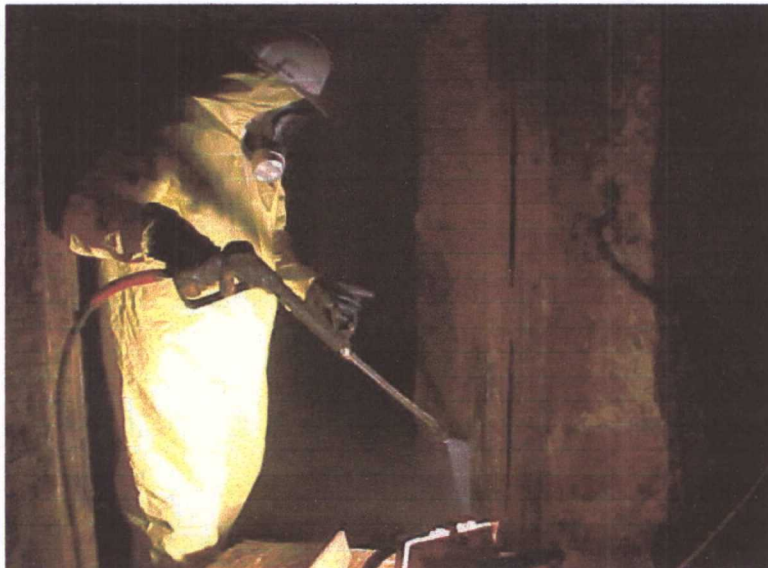
SUBJECT: Power washing walls and ceilings in sub-basement

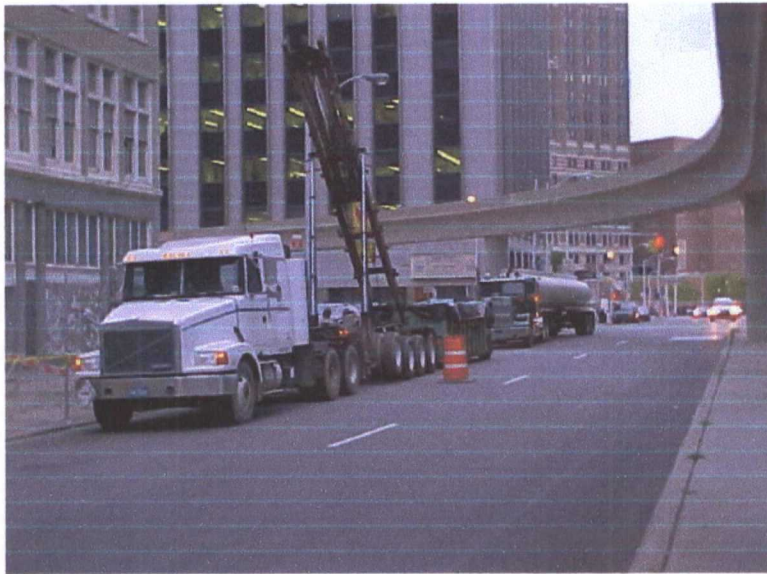
SUBJECT: Empty roll-off delivered to site

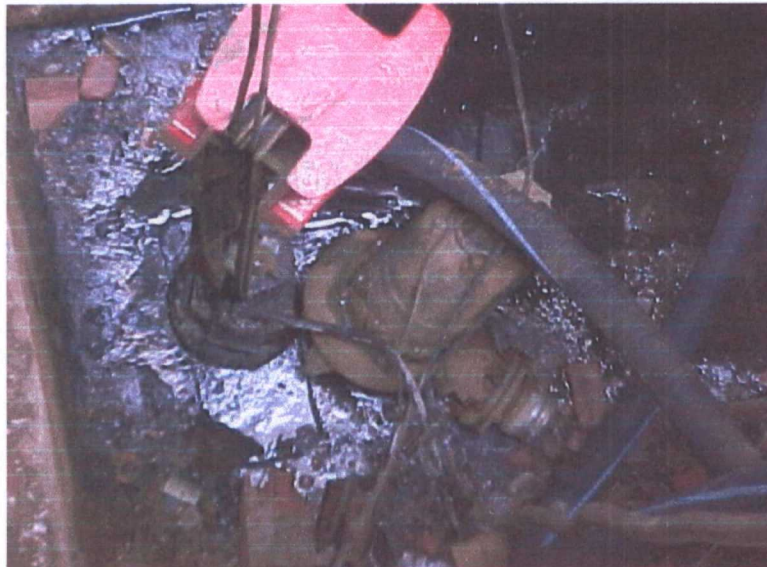
SUBJECT: 4" and 6" pumps, 4" pump removing water from sub-basement

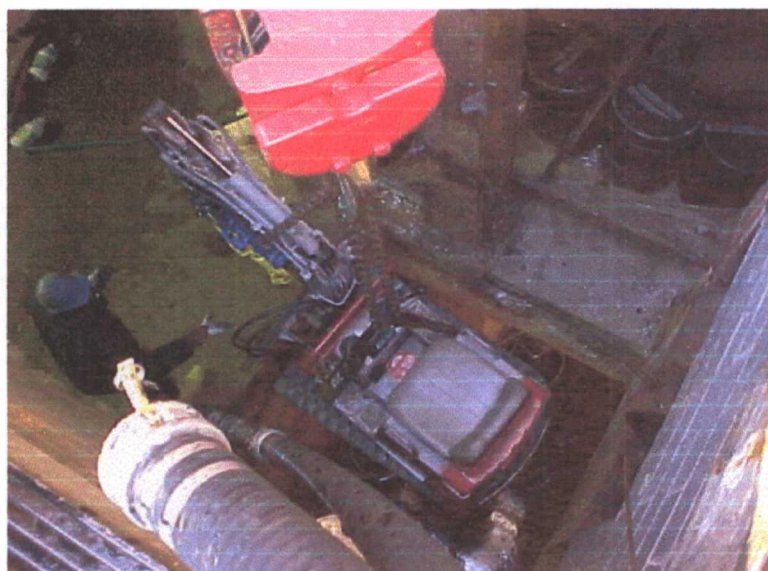
SUBJECT: Mini excavator dropped down to basement

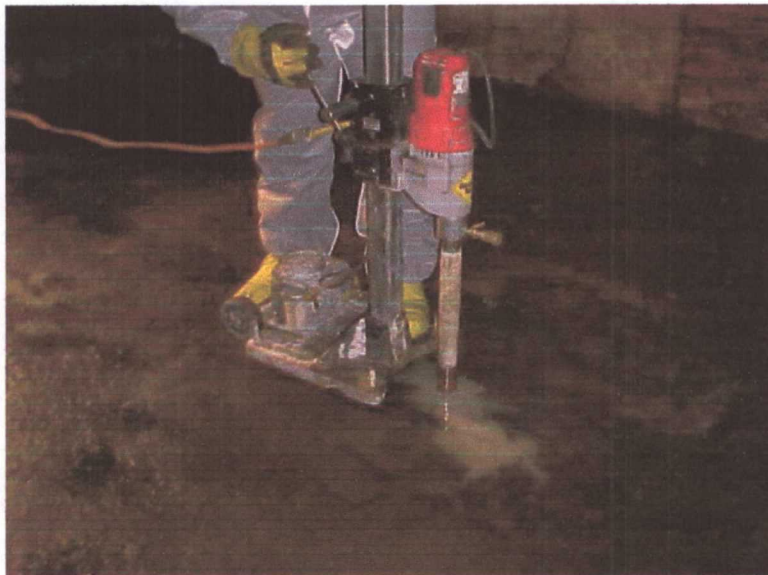
SUBJECT: Concrete corer in sub-basement

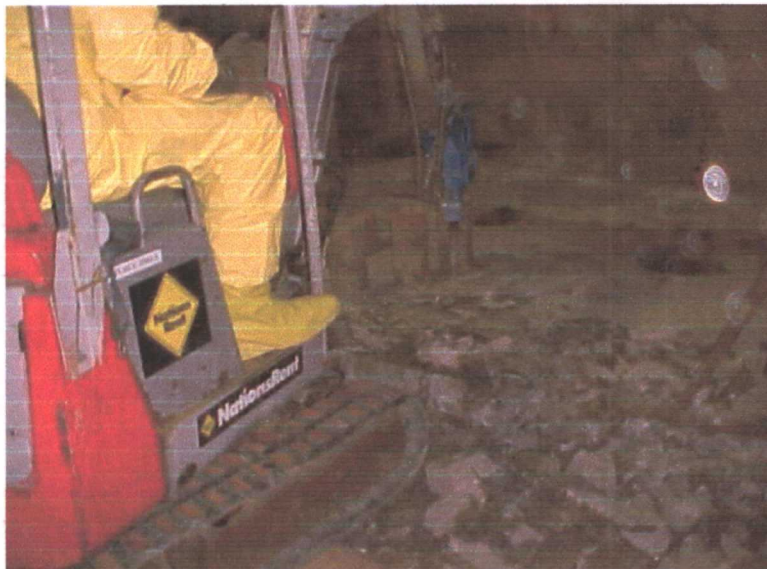
SUBJECT: Mini excavator with jack hammer
breaking concrete in main transformer area

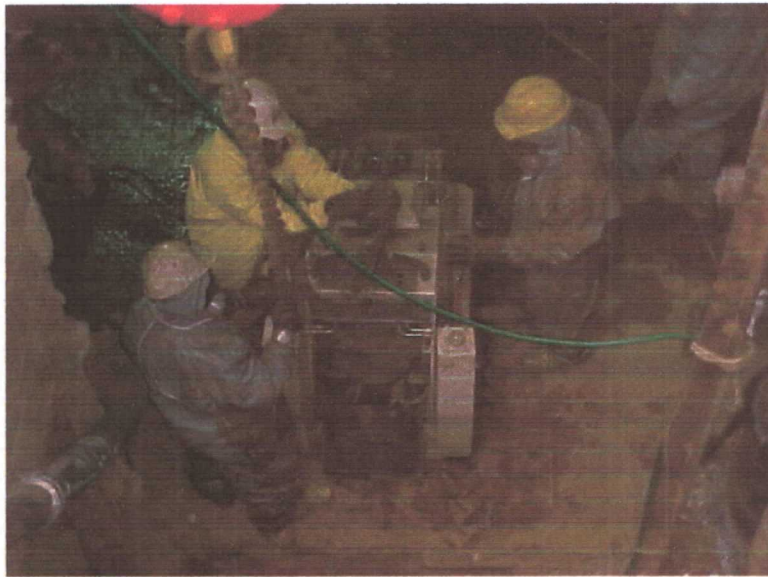
SUBJECT: Mini-loader from sub-basement moved up to basement

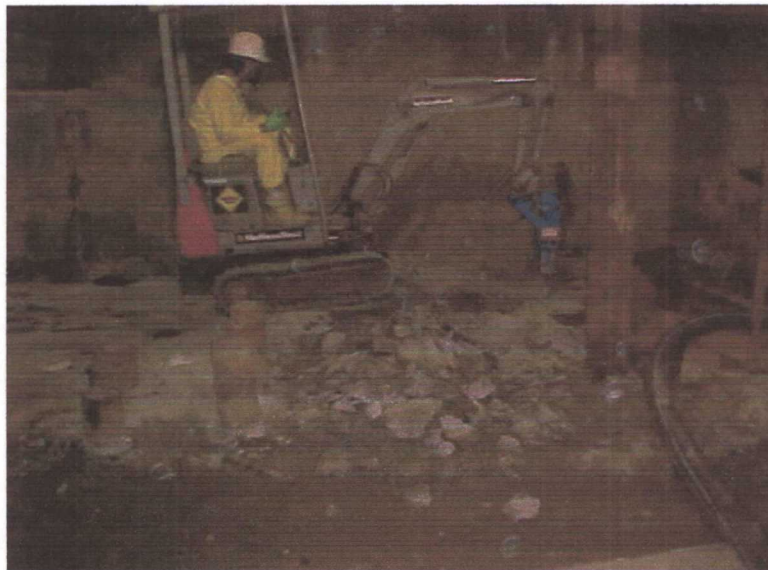
SUBJECT: Jack hammer breaking concrete in basement main transformer area

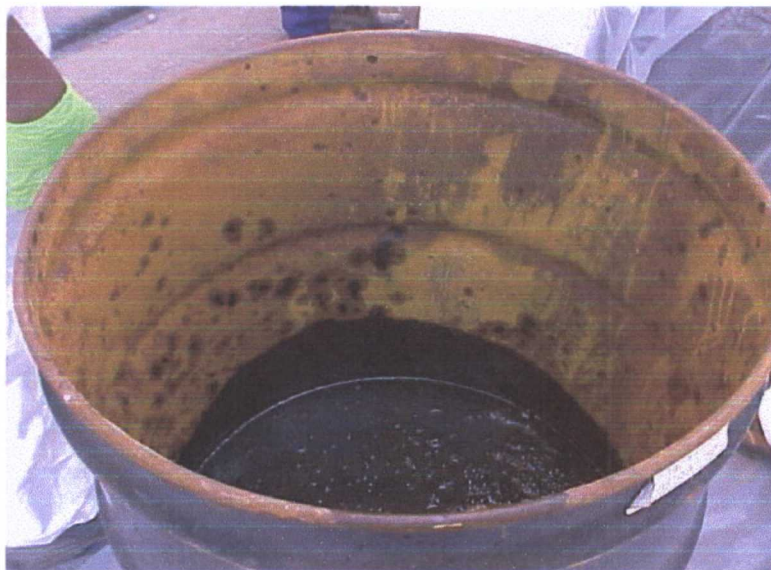
SUBJECT: 55 gallon drum of excess waste in Vac-Truck

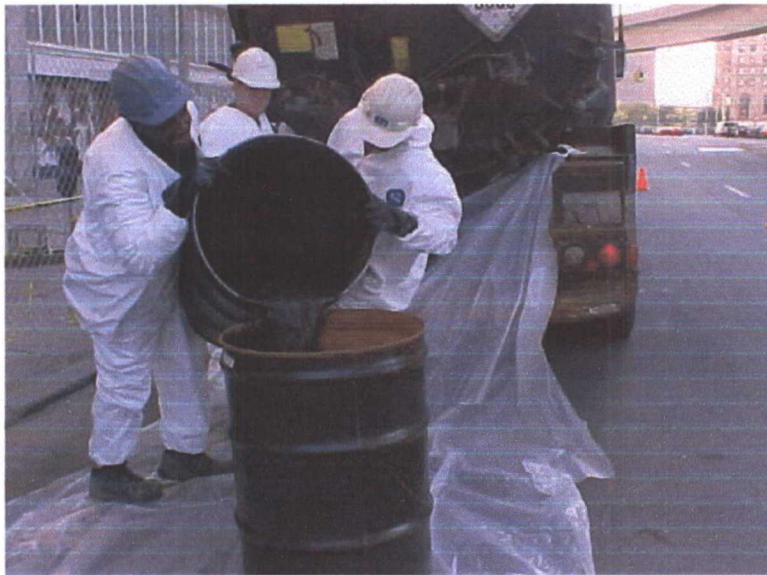
SUBJECT: Waste from Vac-Truck being drummed

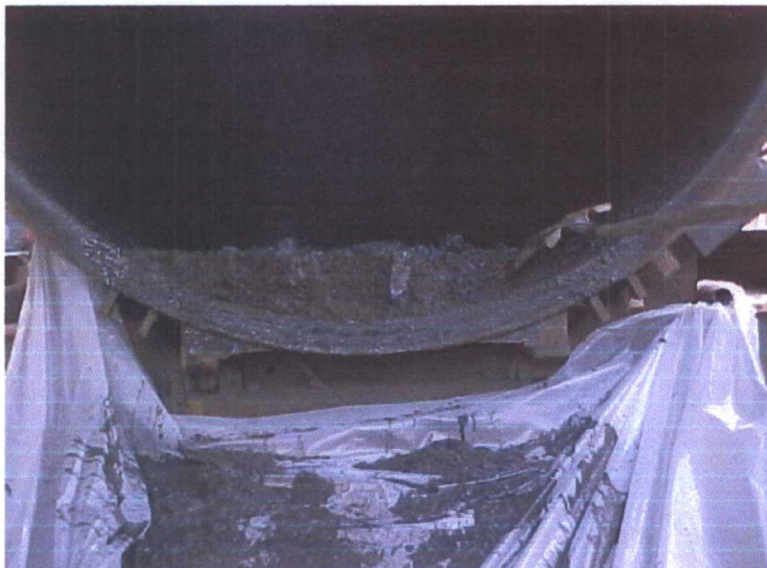
SUBJECT: Layer of debris and excess waste in Vac-Truck that was drummed

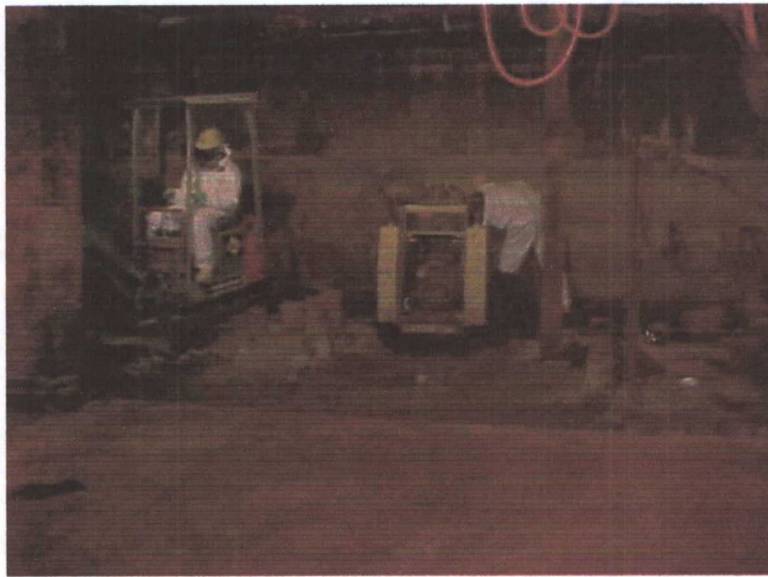
SUBJECT: ERRS personnel busting and removing concrete from main transformer area

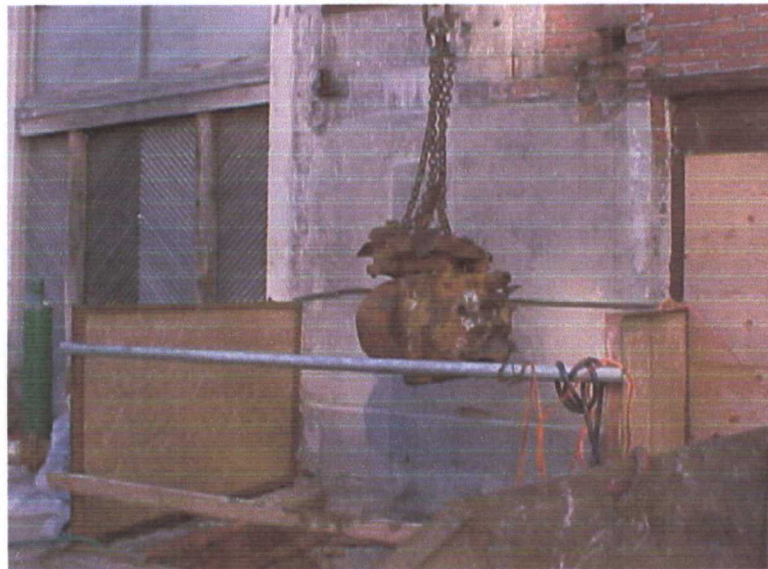
SUBJECT: Capacitor being removed from basement and placed into roll-off

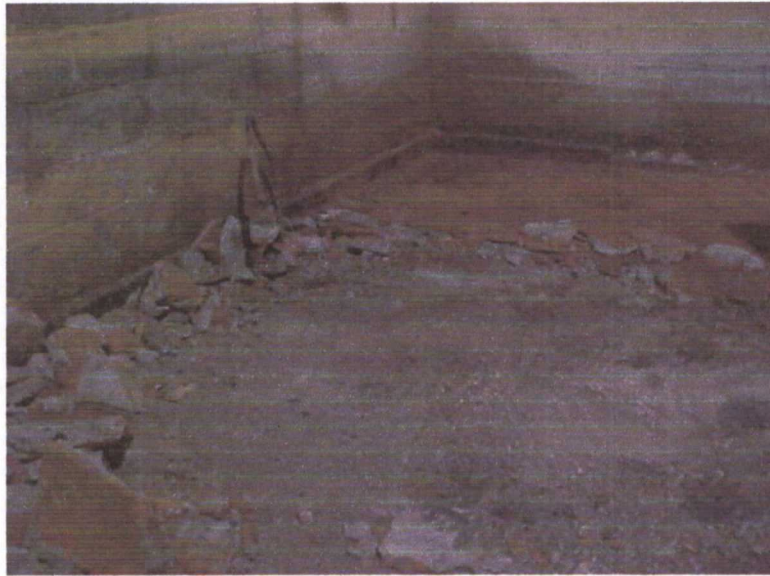
SUBJECT: Busted up concrete and tile in main transformer area

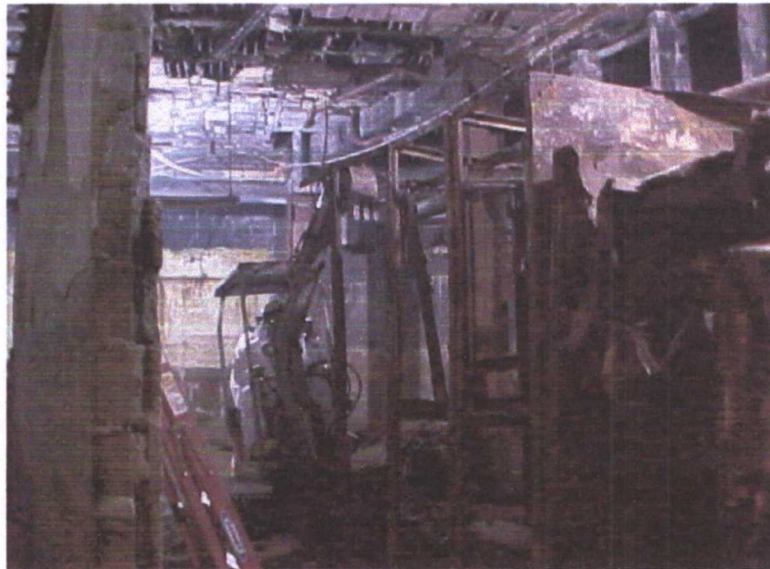
SUBJECT: ERRS personnel removing capacitor closet

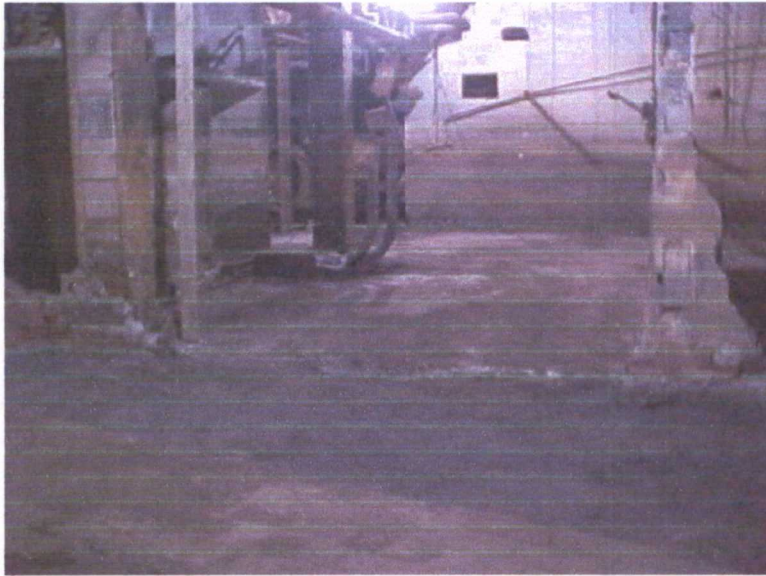
SUBJECT: Main transformer area ready for power washing

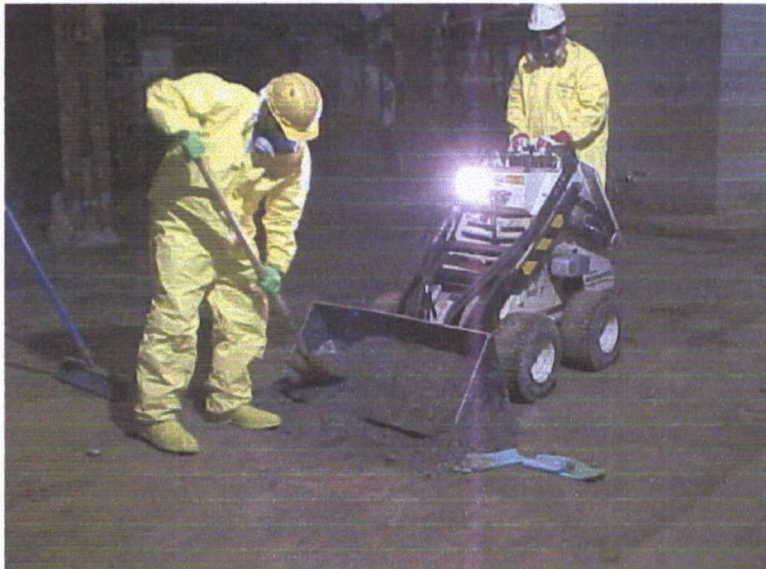
SUBJECT: ERRS personnel removing debris and dust from basement floor

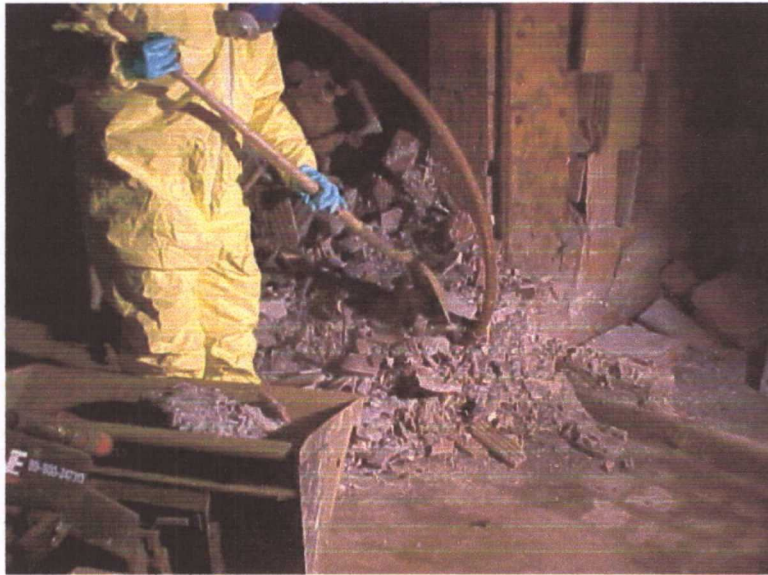
SUBJECT: East side of elevator shaft, ERRS personnel scraping top layer off for disposal and resample

During the week of October 20, 2003, ERRS personnel began scraping and removing all loose debris from machinery and the elevator shaft in the basement. The top layer of debris in the main elevator shaft contained elevated PCB levels. ERRS personnel removed the top layer of debris and resampled the debris (FSHH-SOLID-008 thru FSHH-SOLID-009). Samples were submitted to AA Trinity for PCB analysis. The analytical results for the two additional samples indicated PCB concentrations below 50 parts per million (ppm) and the OSC determined that due to the unstable nature of material in the elevator shaft, no additional debris would be removed. The decision was based in part on the safety of the workers. Suspect ACM samples (FSHH-OT-001 thru FSHH-OT-004) were also collected and submitted to AA Trinity.

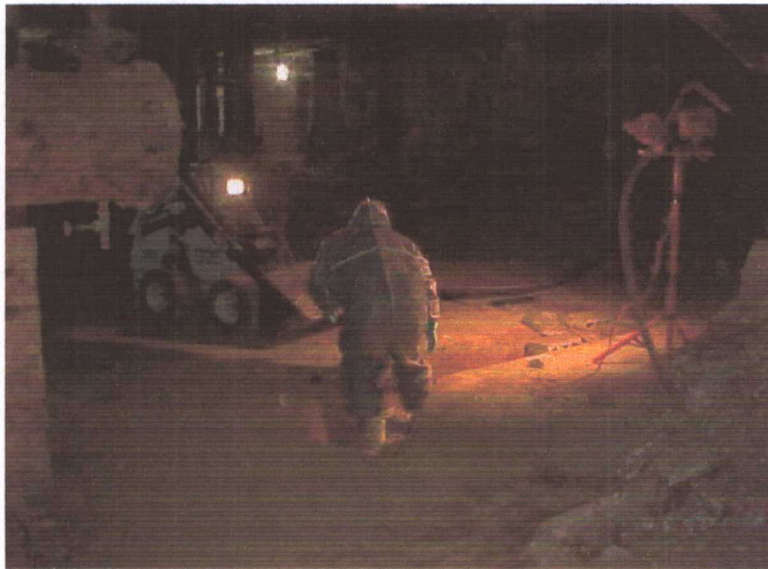
SUBJECT: Crew removing debris from trenches in basement laundry room.

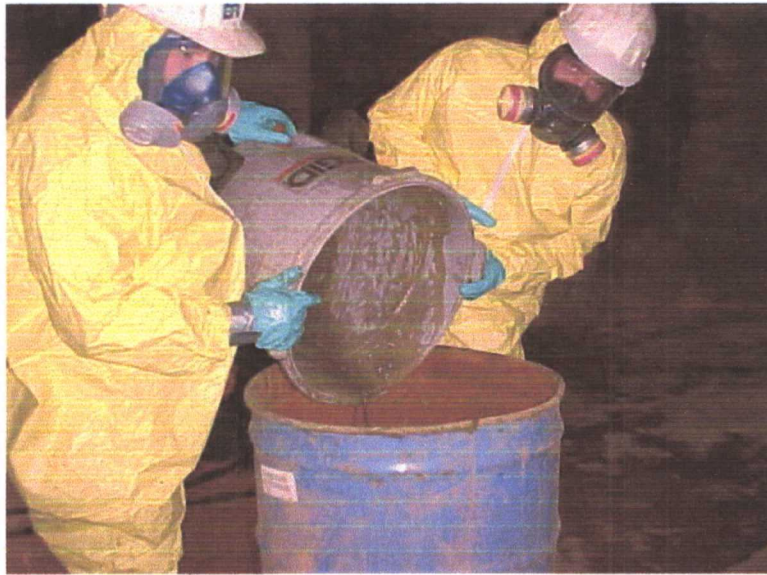
SUBJECT: Crew drumming wash water from machinery room pressure washing.

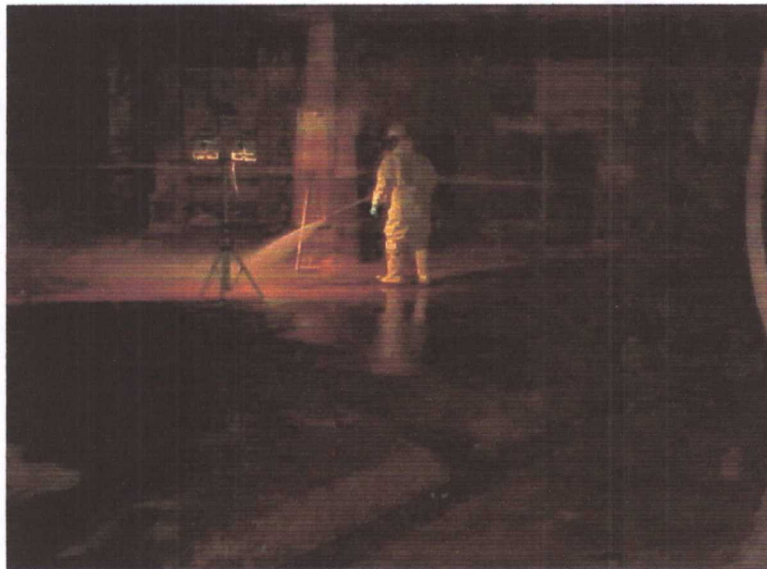
SUBJECT: Pressure washing laundry room in basement

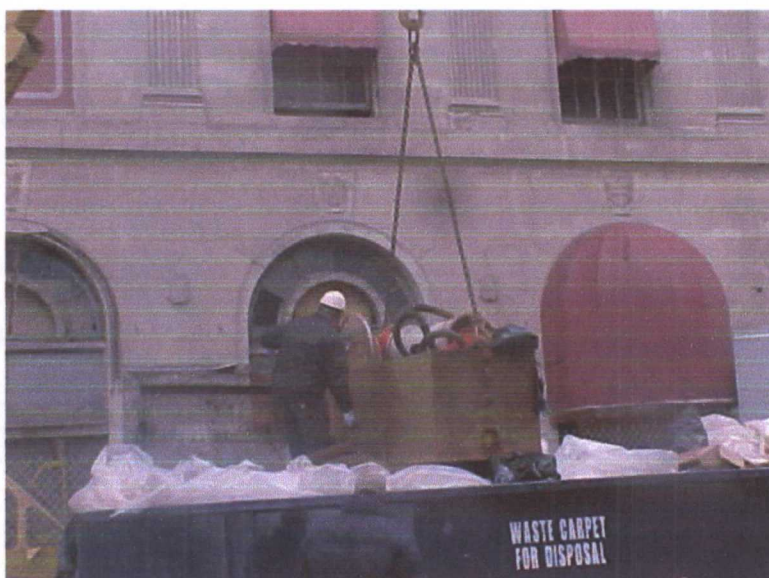
SUBJECT: Shop vac being disposed of into on-site roll-off
